Oak & Fell EIP Annual Monitoring Report: 2015-2016

Project Overview

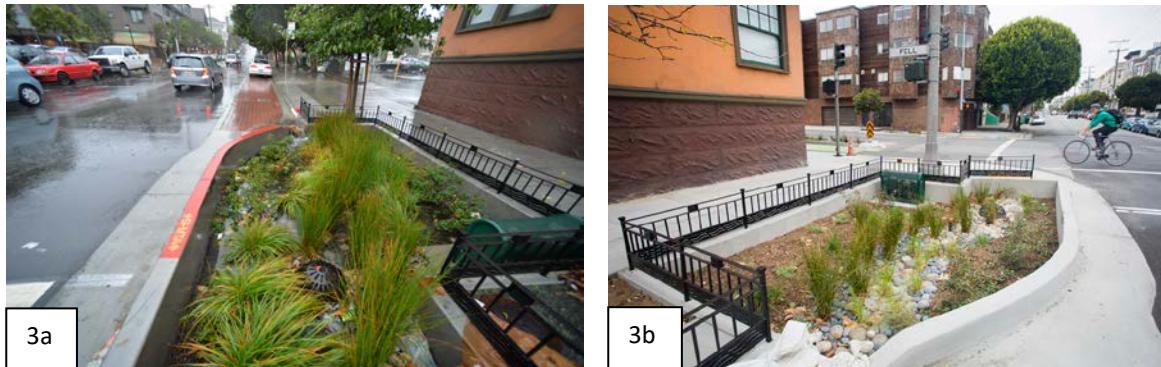
Figure 3a and 3b: The bioretention bulboult planter and permeable paving on the Broderick St SW
(a) from the northern perspective, and (b) from the western perspective

- the southwestern corner of Oak Street at Baker Street (Baker St)
- the northwestern corner of Fell Street at Broderick Street (Broderick St NW)
- the southwestern corner of Broderick Street at Fell Street (Broderick St SW – Figure 3a and 3b)
- the northwestern corner of Fell Street at Divisadero Street (Divisadero St)

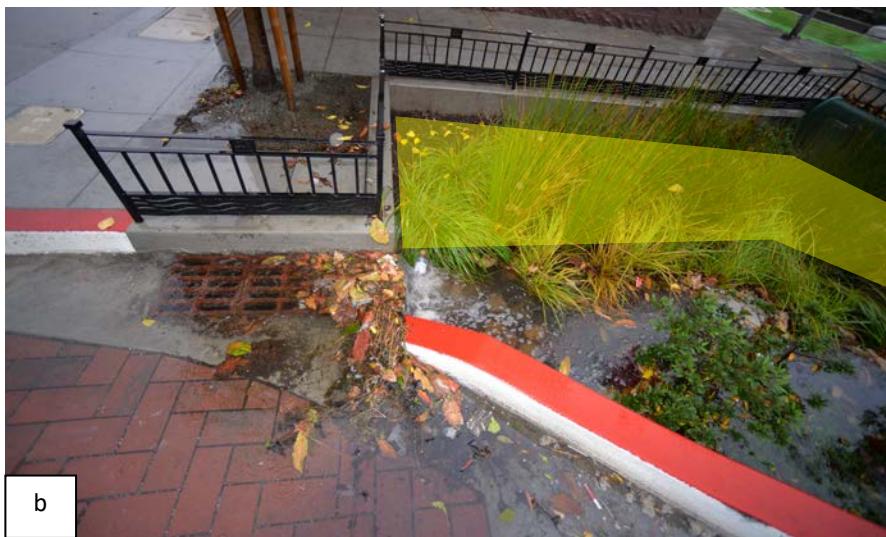
Figure 11 a and b: (a) Schematic section of a typical Oak & Fell bioretention bulbout, (b) the Broderick St SW bulbout during a very large storm event in Dec 2015

- 5) The interior grading inside the four bioretention facilities that was intended to reduce the visual impact of these unusually deep bioretention bulbouts did not maximize available ponding area, which did not allow the bulbouts to perform to their maximum potential (Figure 11 a and b). In the case of the facility at Broderick St NW, a utility corridor forced a portion of the facility interior to be raised, but the other facilities could be more efficient in terms of fully realizing available storage. The highlighted area in Figure 11b shows the area not utilized for storage when the facility is fully ponded.
