Holloway Green Street Annual Monitoring Report 2018-2019

Project Overview

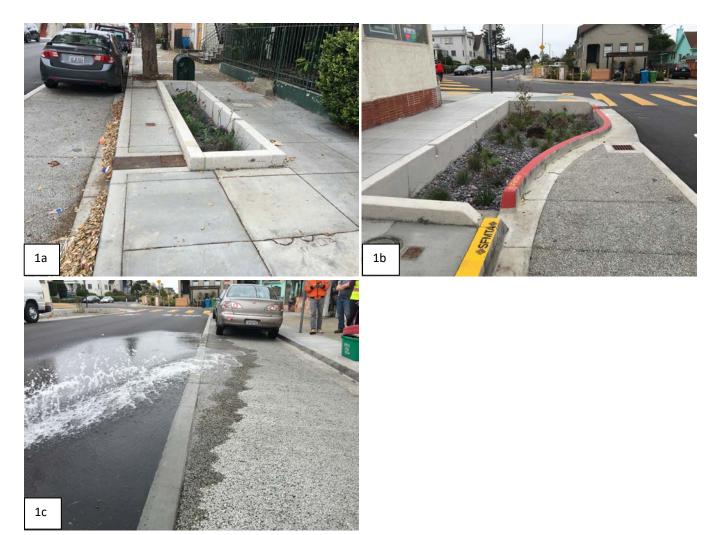
Figure 1a, 1b and 1c: A mid-block sidewalk planter, end-of-block bulbout planter, and pervious concrete.

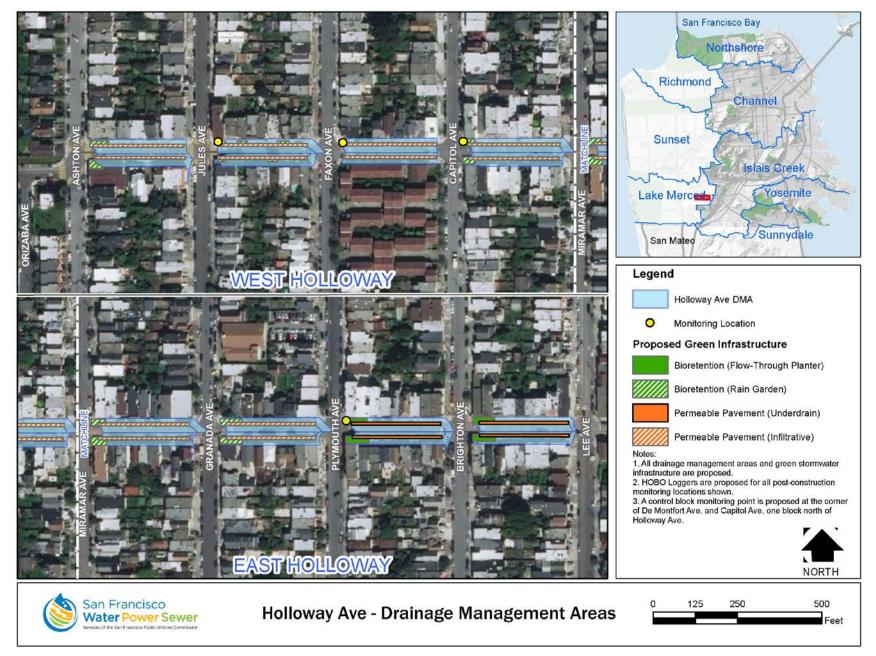
Figure 2: Project overview map

Four blocks, all with varying GI technologies and underlying soil infiltration rates, were monitored for two water years, 2017-2018 and 2018-2019. This report focuses on the 2018-2019 water year, and a summary comparison between the two monitored water years is presented in the Performance Analysis Results section. Performance was evaluated through post-construction flow monitoring in catch basins at the end of each block. Baseline flows (i.e., stormwater runoff under pre-construction conditions) were established by monitoring an unimproved block adjacent to Holloway Avenue. The end-of-block flows were compared against baseline flows, and the difference was credited to facility performance. No monitoring was conducted prior to construction. The five monitoring locations including the baseline block and four GI locations (Figure 2) are located at:

- Capitol @ DeMontfort (baseline block)
- Holloway @ Jules (Mid block planters & pervious concrete)
- Holloway @ Faxon (Only pervious concrete)
- Holloway @ Capitol (End of block planters & pervious concrete)
- Holloway @ Plymouth (Underdrained end of block planters & underdrained pervious concrete)

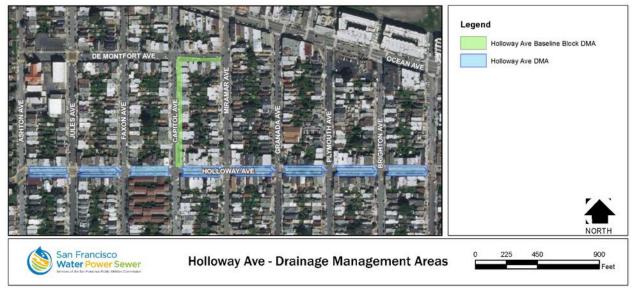
Figure 3: Location of the baseline block relative to the project area

Figure 3 shows the spatial relationship between the baseline block and the project area.

Table 1 provides the DMAs for both the baseline block and the monitored blocks, as well as the sizing ratio for the GI technologies. The baseline block DMA is larger than the project block DMAs because it is located on a corner where the two intersecting streets both drain to the catch basin. The DMAs were delineated using the subcatchment layer from the City and County of San Francisco (CCSF) Hydrologic and Hydraulic model and were then adjusted according to field observations of drainage patterns during wet conditions.

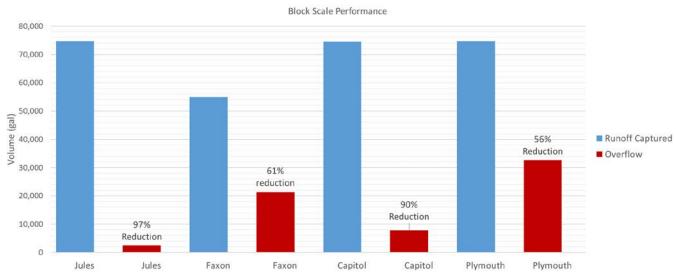
Figure 4: Monitored block performance for the 2018-2019 monitoring period.

Overflow from the monitored blocks was significantly less than the baseline flow for all blocks. Measured across the whole rainy season, monitored volume reduction at the four blocks ranged from 56%-97% with an average 77%. Performance is strongly correlated to infiltration rate with the best performance at the western end of the project and generally decreasing to the east. The SWMM model was in general agreement with the monitoring results, estimating that GI reduced runoff volume by 83% across the four monitored blocks, and by 79% across the full project area. The SWMM model slightly oversimulated performance compared to the 2018-2019 monitoring results (83% modeled reduction versus 77% measured reduction for the four monitored blocks), while the 2017-2018 monitoring period slightly undersimulated performance (75% modeled reduction versus 78% measured). This may be a product of the porous media having slightly decreased infiltration capacity year over year due to deposition of fines in the pore space. According to both the monitoring results and the supporting modeling results, the overflow from the Model Block was significantly less than the baseline flow during the 2018-2019 monitoring period (Figure 8).

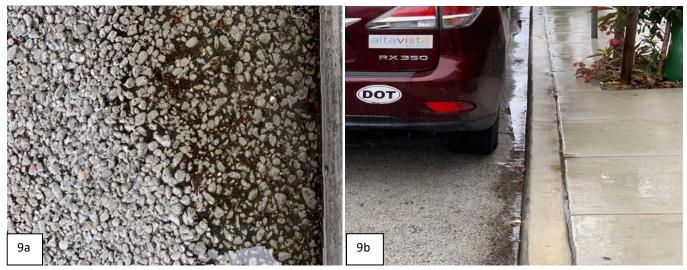
Figure 5a and 9b: Fines clogging the pervious concrete, informal gutter formed at edge of curb.

The SFPUC decided to install pervious concrete all the way up to the curb on the Holloway x Faxon block, with the knowledge that fines might accumulate at the low-lying edge along the curb. The advantages of this configuration include less formwork during construction and, even though the concrete adjacent to the curb may become clogged and function as an informal gutter, heavier flows during intense rainfall spill farther out into the street where they can infiltrate through the cleaner concrete. Field reconnaissance in January 2019 confirmed that a thin swath of the permeable pavement had become clogged (Figure 9). As a result, the sidewalk portion of the DMA on this block is not fully managed because it mostly drains into the informal gutter and flows to the catch basin at the corner; there are no bioretention planters on this block to intercept gutter flow. This explains why monitored performance on this block was less than predicted by the model. Approximately 45% of the DMA on this block comes from the sidewalk. If the pervious concrete is assumed to manage 100% of the roadway runoff, as predicted by the model and supported by visual observation, then monitoring results for the 2018-2019 monitoring period indicate that effectively 20% of annual sidewalk runoff volume is managed by the pervious concrete while the other 80% flows directly to the catch basin. Results from the 2017-2018 monitoring period indicated that 25% of the sidewalk was effectively managed by the permeable pavement that year. The swath of clogged pavement abutting the curb may have widened slightly from one year to the next due to the deposition of additional fines and the vac trucks inability to clean that close to the curb.

- 1) The Faxon block includes only pervious concrete, no bioretention planters. The pervious concrete was installed all the way up to the curb with no formal gutter. This was done with the knowledge that fines might accumulate and clog a narrow swath along the low-lying edge against the curb, which has happened. While this had a significant impact on performance during both years of monitoring 75-80% of the sidewalk runoff drained directly to the downstream catchbasin there is no drawback as compared to installing a formal gutter, which would have cost more and guaranteed no management of any sidewalk area. Overall, this configuration was not problematic and increased cost effectiveness compared to pervious concrete with a traditional curb and gutter. The formation of the informal gutter demonstrates that the City's standard vac trucks are not able to remove sediment all the way up to the curb. The rotating brushes do push a good portion of the sediment to where the vacuum component can capture it, but the scouring action also pushes some of the sediment down into pervious concrete's pore spaces.

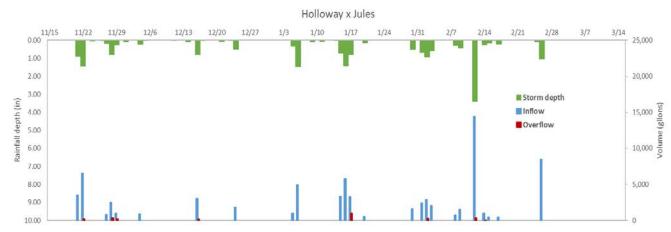
Figure 6: Hydrograph showing inflow and GI overflow of the 2018-2019 Monitoring Period at Holloway x Jules

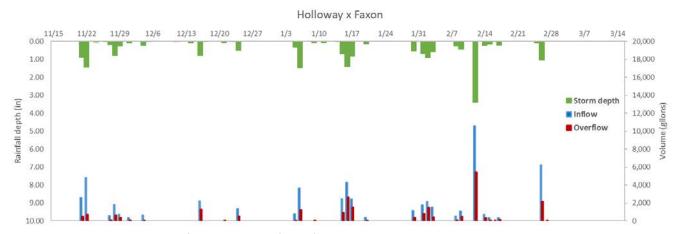
Figure 7: Hydrograph showing inflow and GI overflow of the 2018-2019 Monitoring Period at Holloway x Faxon

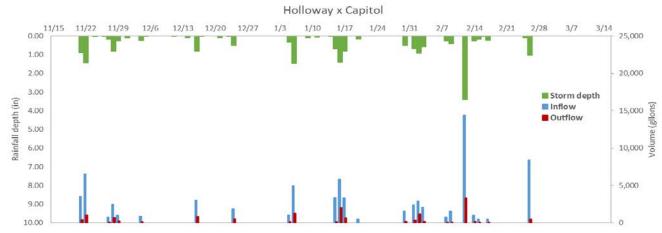
Figure 8: Hydrograph showing inflow and GI overflow of the 2018-2019 Monitoring Period at Holloway x Capitol

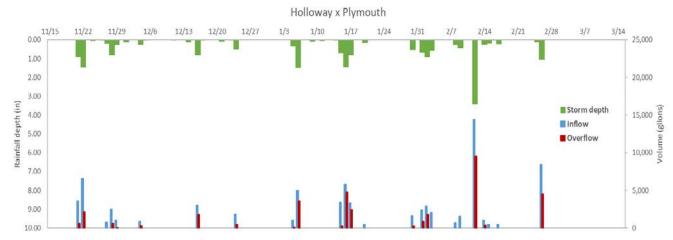
Figure 9: Hydrograph showing inflow and GI overflow of the 2018-2019 Monitoring Period at Holloway x Plymouth

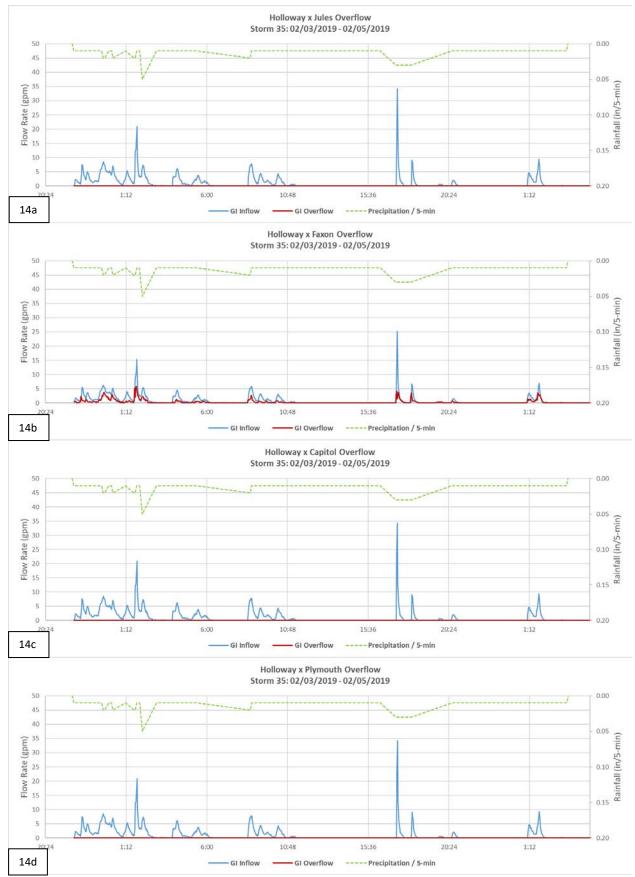
Figure 10: Hydrographs for Storm 35 at Holloway x a) Jules, b) Faxon, c) Capitol, d) Plymouth

Storm 35 (Figure 14) represents a low-intensity storm with steady rainfall totaling 0.58 inch over the course of 29 hours starting late in the day on February 3, 2019. A larger storm ended ended earlier in the day so antecedent soil conditions were saturated. Despite that, the consistent low intensity rainfall allowed the GI facilities to fully manage all of the runoff they recieved; it is assumed that the runoff not managed on Faxon flowed directly to the catch basin via the informal gutter.

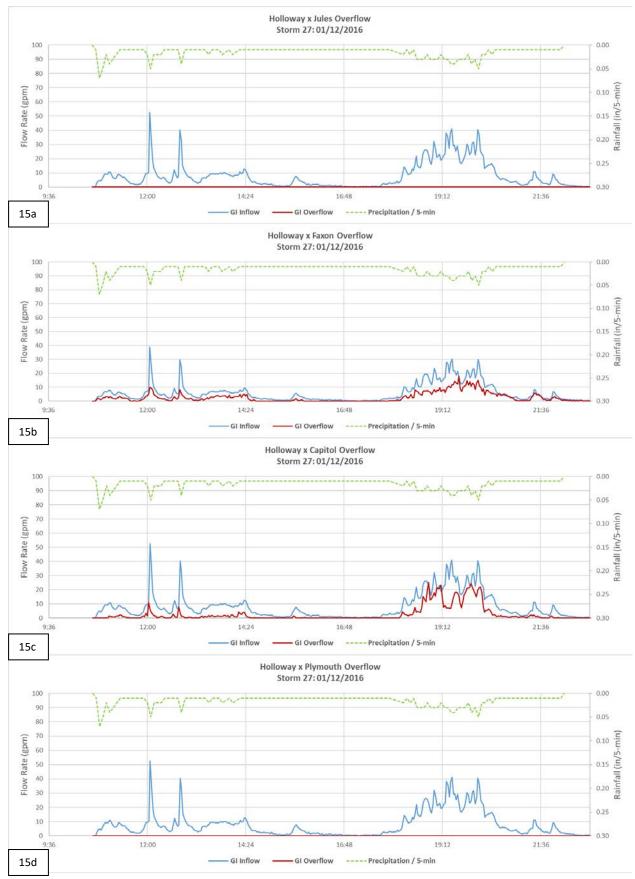
Figure 11: Hydrographs for Storm 27 at Holloway x a) Jules, b) Faxon, c) Capitol, and d) Plymouth

Figure 15 shows the hydrographs for a relatively large storm event on January 16th, 2019, Storm 27, which produced 1.42 inches of rainfall over the course of 11 hours, including an intense burst at the onset around noon and another later that evening. A moderate storm producing 0.7 inches of rain ended early that morning, so this was the second of a back-to-back storm. There was a wide range of monitored performance across the four blocks during this storm. Unlike Storm 25, which was smaller and less intense, most blocks were not able to fully manage this storm, the exception being Jules. Performance at Faxon was relatively consistent the whole time, hovering around the 59% reduction total for the storm, which reflects the active permeable pavement's ability to manage the vast majority of the runoff it receives. This storm provides a clear illustration of how the initial portion of a storm is absorbed by the storage within the GI facilities. Both Capital and Plymouth performed better at the onset of the storm, then performance deteriorated as storage was exhausted. Capitol absorbed most of the first burst and the ensuing low-intensity rainfall until around 7:00 PM when storage was overwhelmed by the second burst. Plymouth has the poorest draining soils and, given the wet antecedent soil conditions, was only able to absorb the initial portions of each burst and then entered a flow-through condition.

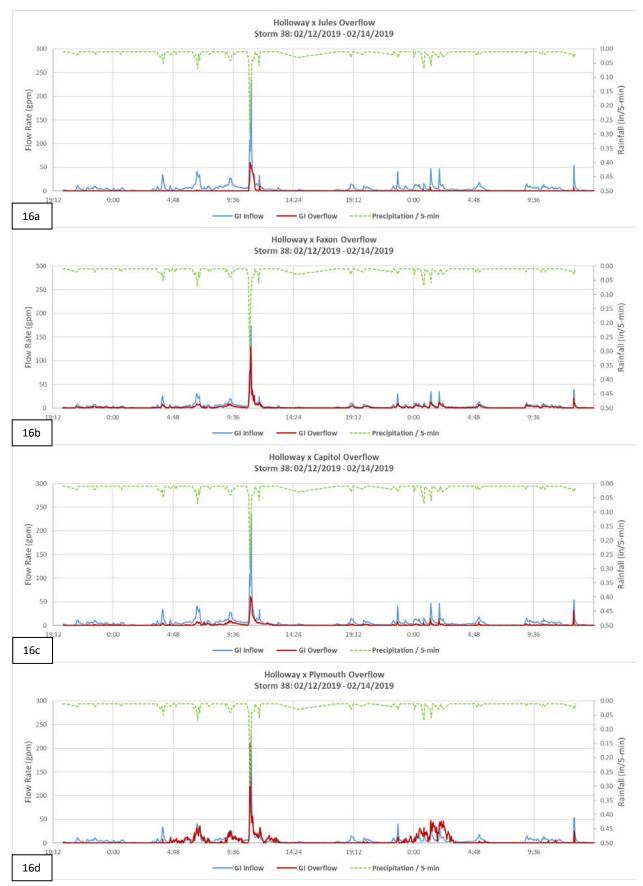
Figure 12: Hydrographs for Storm 38 at Holloway x a) Jules, b) Faxon, c) Capitol, and d) Plymouth

Storm 38 (Figure 16) was the largest storm of the monitoring period and also contained the most intense burst. It had been almost three days since the previous storm, so all facilities started out with ample storage. The storm lasted almost two days with a total depth of 3.4 inches, including 0.58 inch over a 30-minute period late in the morning on February 13th. As with Storm 27, there was a wide range of monitored performance across the four blocks. None of the blocks were able to fully manage the storm. Jules managed virtually the entire storm outside of the one huge burst, reducing overall volume by 96% and significantly dampening the peak flow. Capital also performed well, significantly reducing volume by 86% and dampening peak flows. As with most storms, Faxon performed consistently, but was overwhelmed by the large burst. The storage at Plymouth was exhausted around eight hours into the storm, and GI on this block was not effective in managing most subsequent flows by either measure of volume or peak flow.
